**Docket No. 217 – Development and Management Plan Inspection**

Northeast Utilities Service Company Certificate of Environmental Compatibility and Public Need for the construction of a 345-kV electric transmission line and reconstruction of an existing 115-kV electric transmission line between Connecticut Light and Power Company's Plumtree Substation in Bethel, through the towns of Redding, Weston, and Wilton, and to the Norwalk Substation in Norwalk, Connecticut.

**Date:** April 19, 2006

**Location:** 115 kV Underground Route

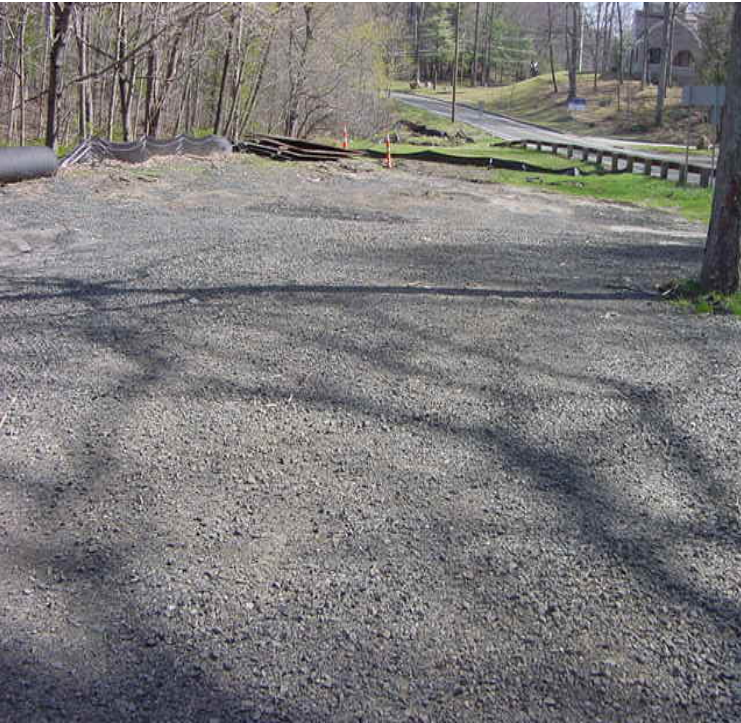
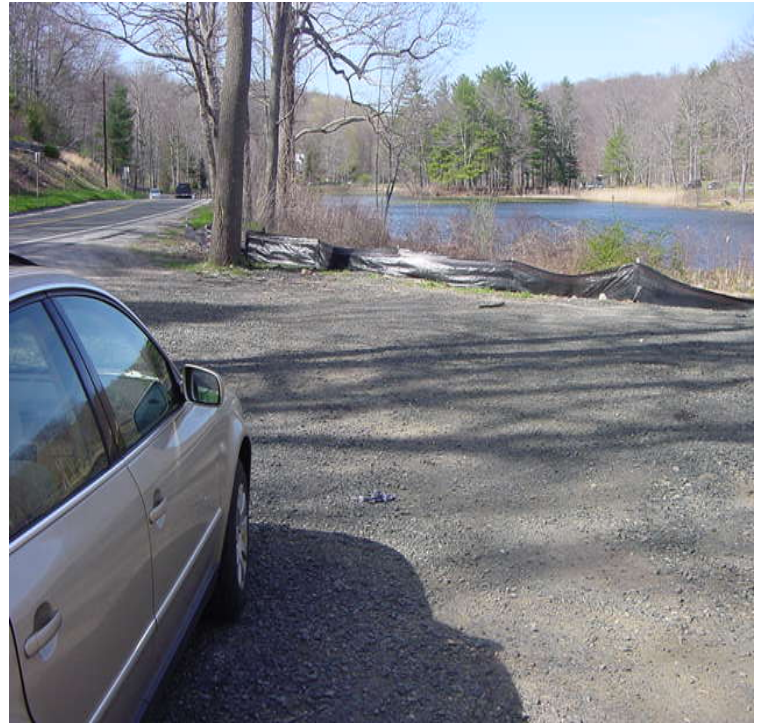
115kV (Putnam Park): Both photos show a view of the storage area with controls well in place. 4/19/06

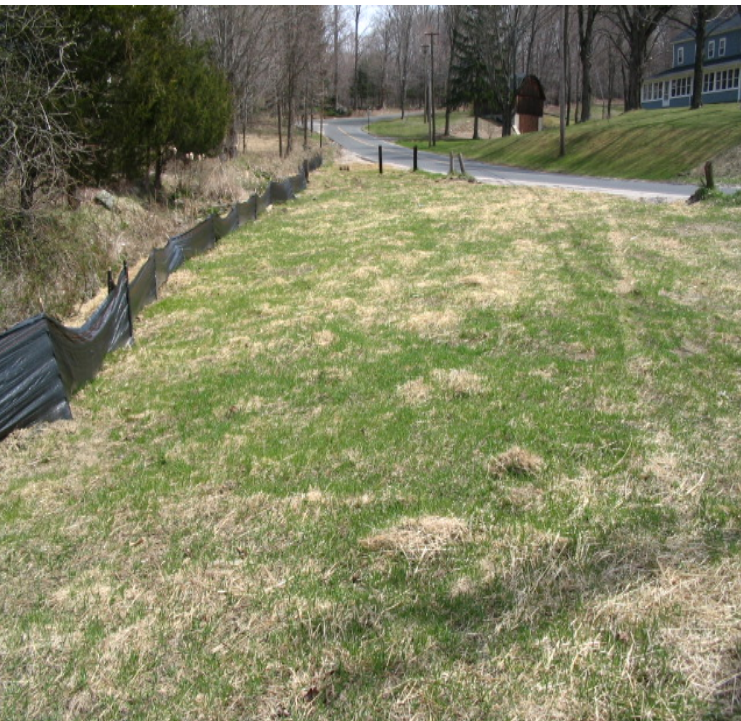
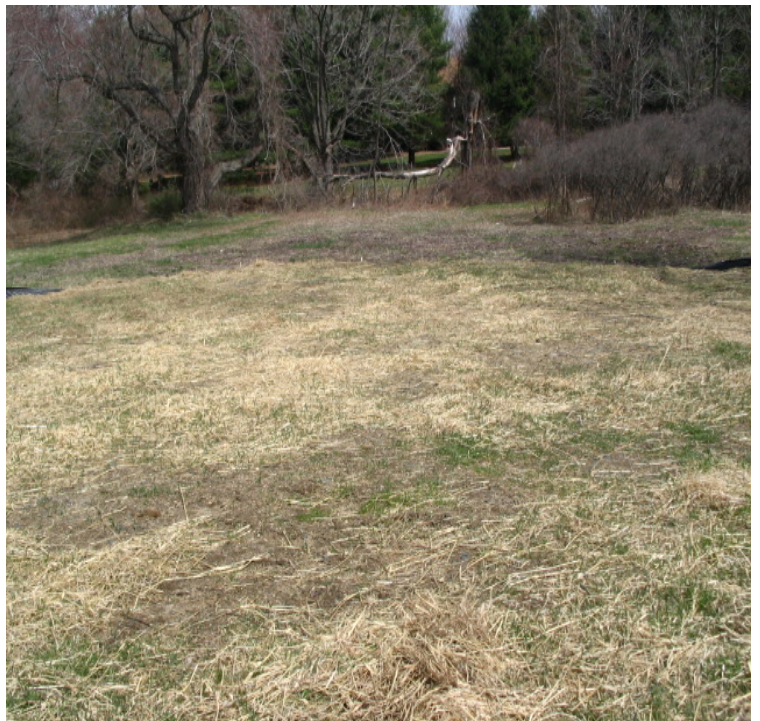
115kV (Sunset Hill and Rt 107): Both photos show the various storage areas with increasing grass growth and stabilization. 4/19/06
